# North American Wind Farm Benefits from Main Bearing Life Extension

*Romax unique life-extending grease flushing process enables repairs to be postponed for up to two years*

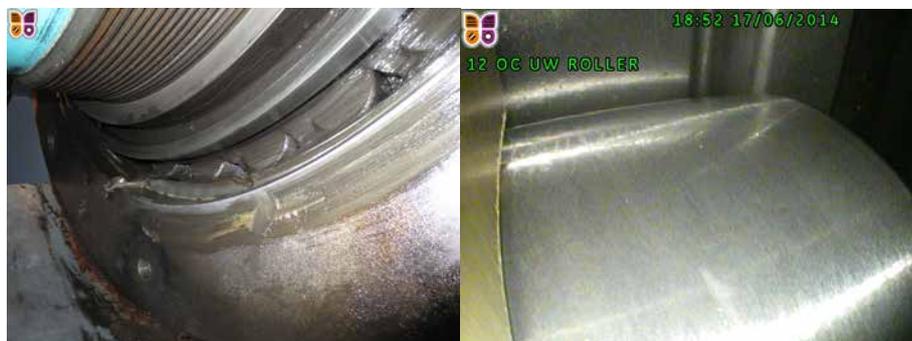
*Bearing in as found condition (left) and after flushing to remove grease (right)*

Romax's proprietary uptower grease flushing process removed highly contaminated grease from the main bearing, with Romax then repacking with clean grease.

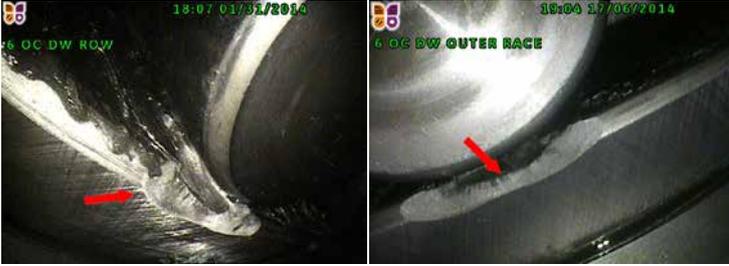
*Outer race fracture after first flush (left) and 5 months later (right), showing damage progression has slowed*

During the flushing procedure Romax engineers inspected the bearing, finding micropitting on the rollers and severe damage (macropitting and cracks) on the outer race (load zone) and inner race/rollers. The engineers then removed more than 95% of the grease using Romax's flushing process\*, allowing a complete repacking with fresh grease.

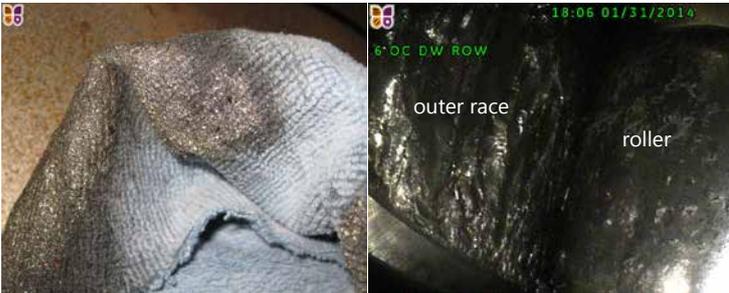
*Debris evident in original flush grease (left), outer race condition before first flush (right) showing severe spalling*

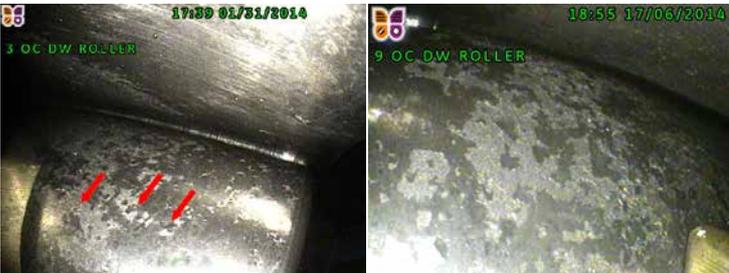
*Micropitting and debris denting on the roller at first flush (left) and 5 months later (right) damage progression has slowed*

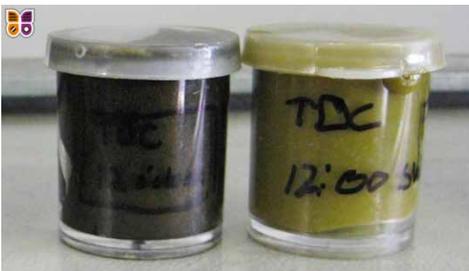
*Typical samples showing condition of grease before flushing (left) and improved quality 5 or more months after flushing (right)*
